## **SCALE REMOVAL STUDY**

Cooling Tower #2, MountainView Hospital Las Vegas, Nevada

Conducted: September 26 – October 2, 2002

**Author:** Eric Christensen, AIA  
**Report Date:** October 7, 2002

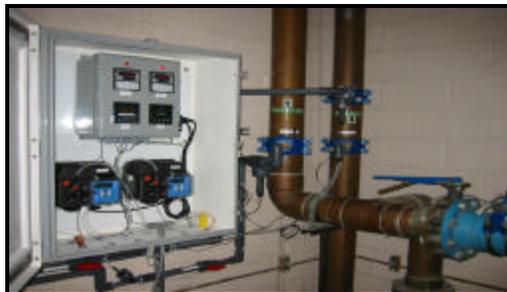
**OXCIDE** Treatment System Treating all Hospital Water

Make up water: TDS 336, pH 7.77, ORP 650 mV (NOTE: Make up water is pre-treated with **OXCIDE** via the **OXCIDE** water treatment system that treats the entire hospital water distribution system)

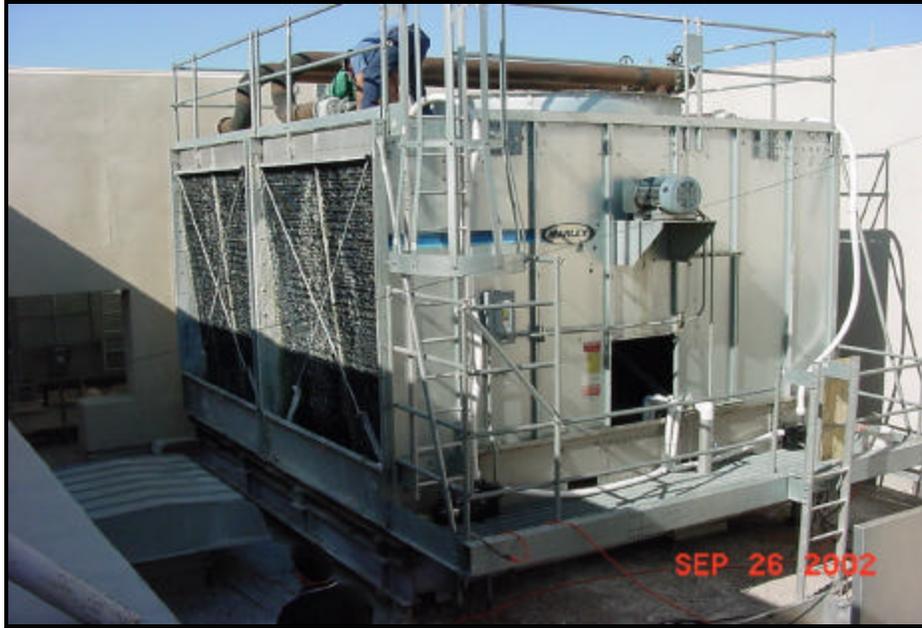
**MountainView Hospital 3000 ton Marley Cooling tower. Note: Since the tower was off line, manual circulation pumps were required.**

Two temporary external 1.5 hp pumps with 2" diameter hoses were used to circulate treated water over the media. (One pumps and hose for each side)

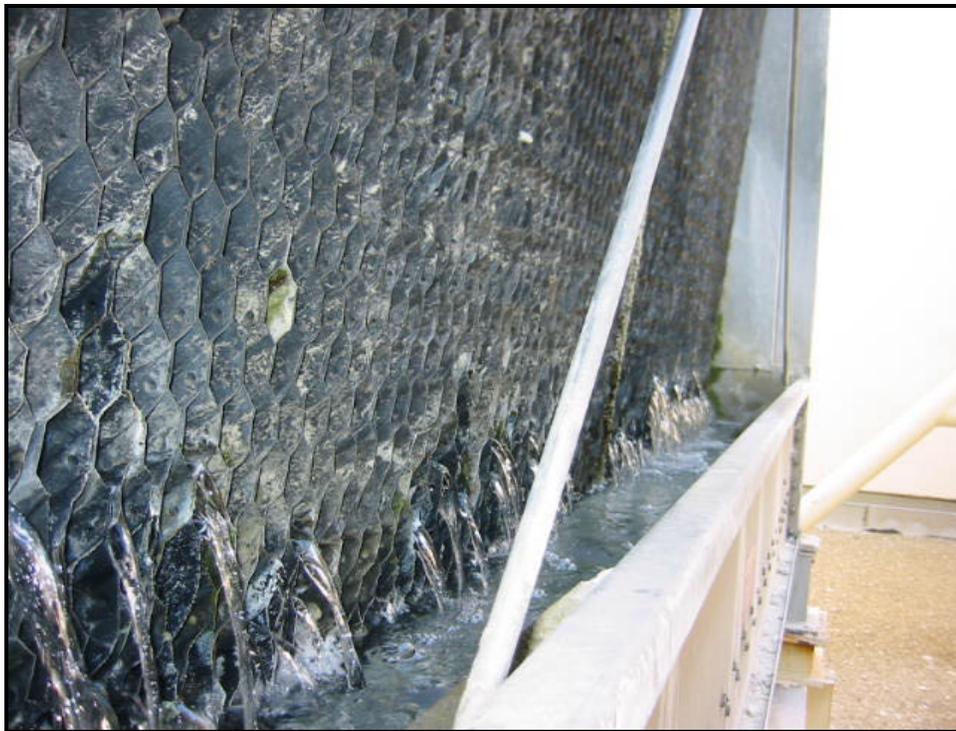
**Scale accumulation causing water spouts prior to treatment  
NOTE: Engineering attempted manual clean 3 days prior**

The tower chosen, Tower #2, had been mechanically cleaned three days earlier by hospital staff. Nonetheless, significant scale deposits were present throughout the media, with extreme deposits at the lower section.

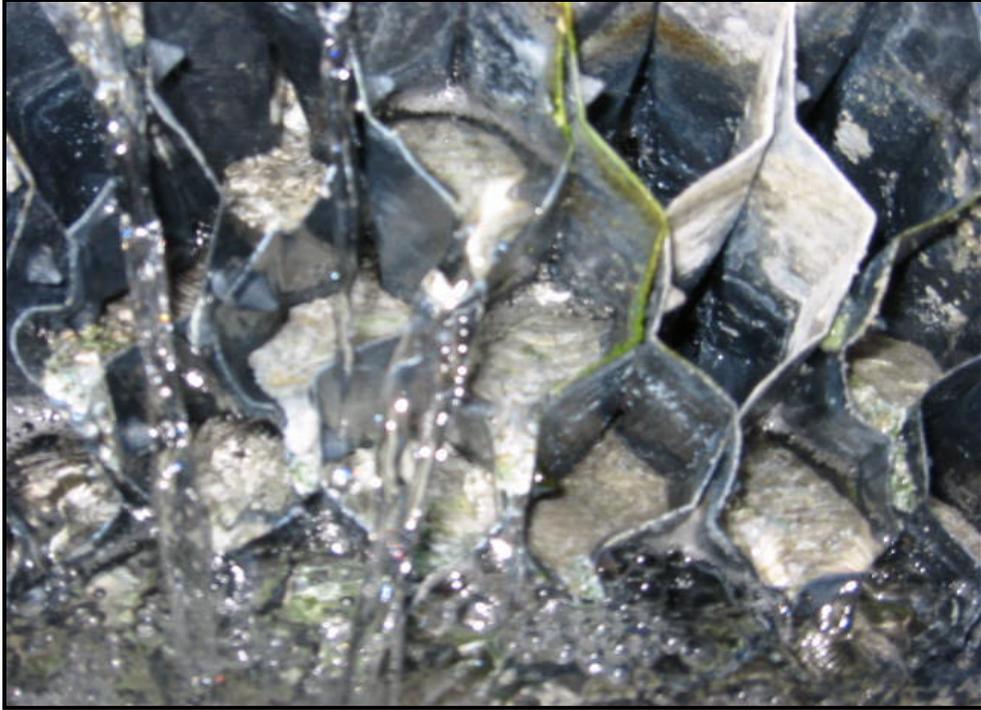
Scale accumulation near water level on media.

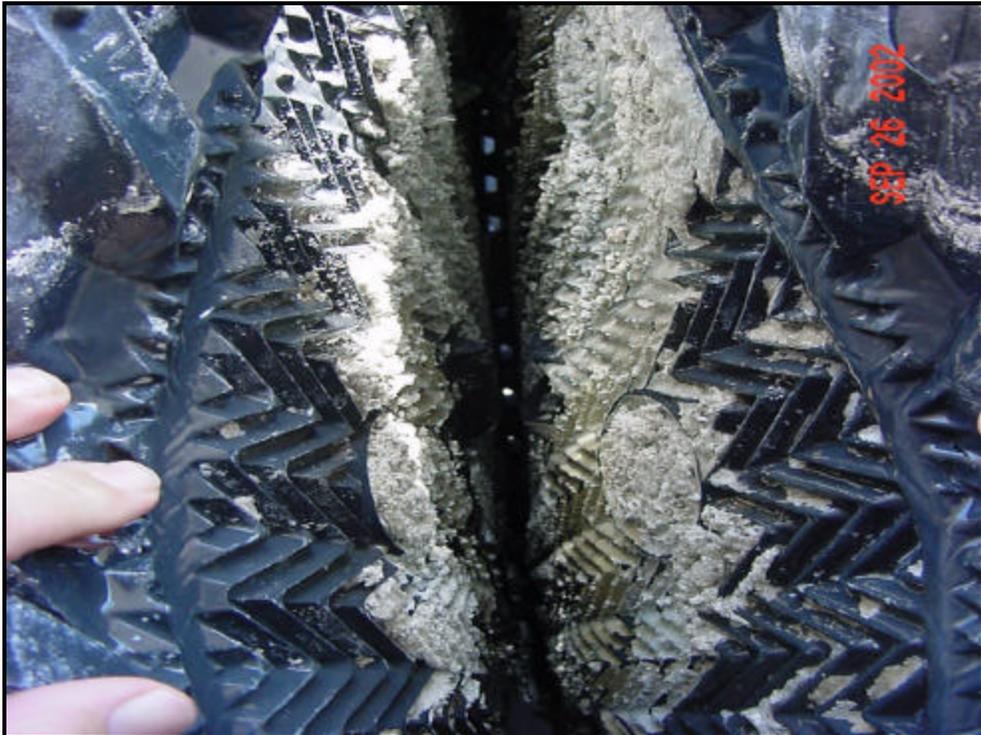
Scale deposit on media prior to treatment.

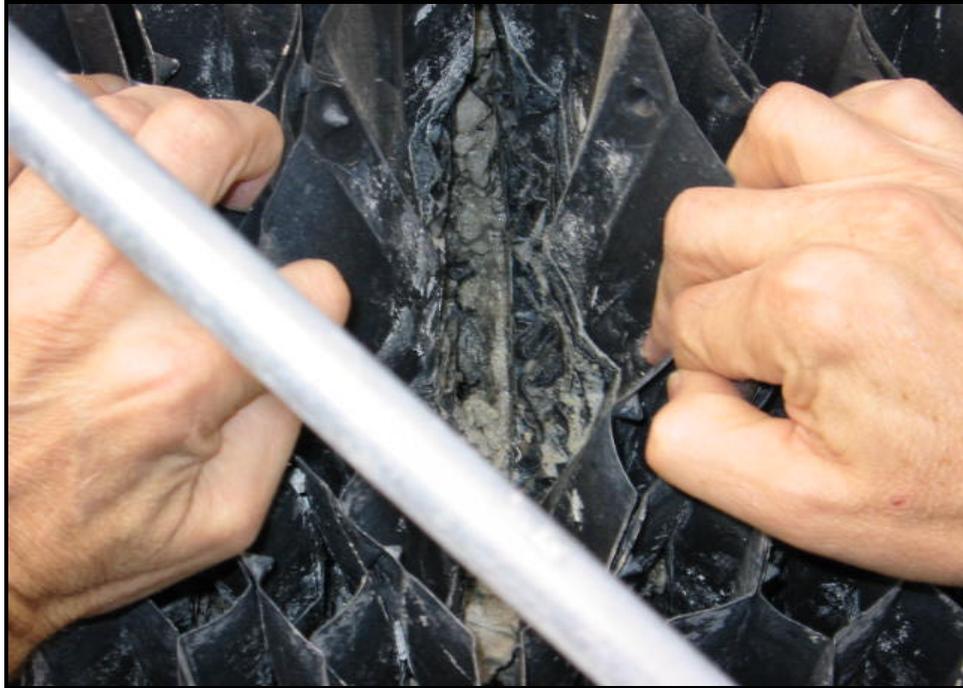
Media condition after 8 hours **OXIDE** treatment showing softening of scale deposits. Note difficulty in separating media.

The scale that had dropped out of media was shoveled out/hosed down drain. Scale generally became softer and more granular. Many large chunks of scale were dislodged. Tower was refilled.

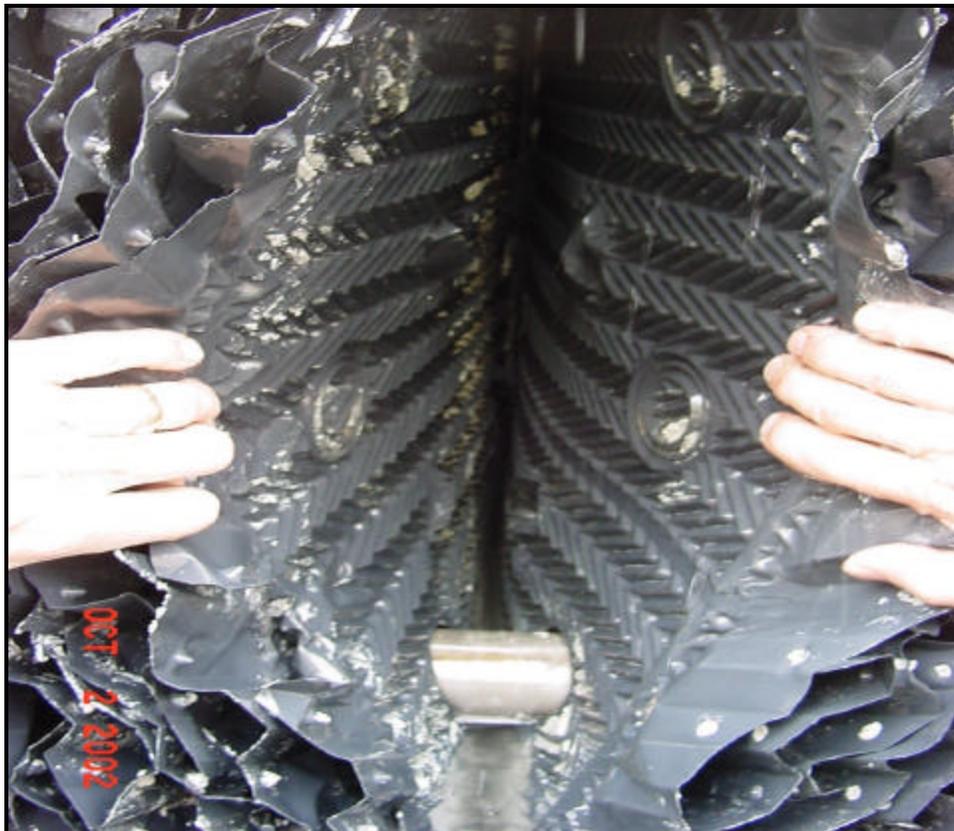
Media condition after **OXIDE** treatment

It was felt that the 1.5 hp pumps could not supply enough water to wet all media surfaces to reach full decalcifying effect in a short run time. Media was approximately 90% clean. , The media surface was clear of scale wherever water contacted media.

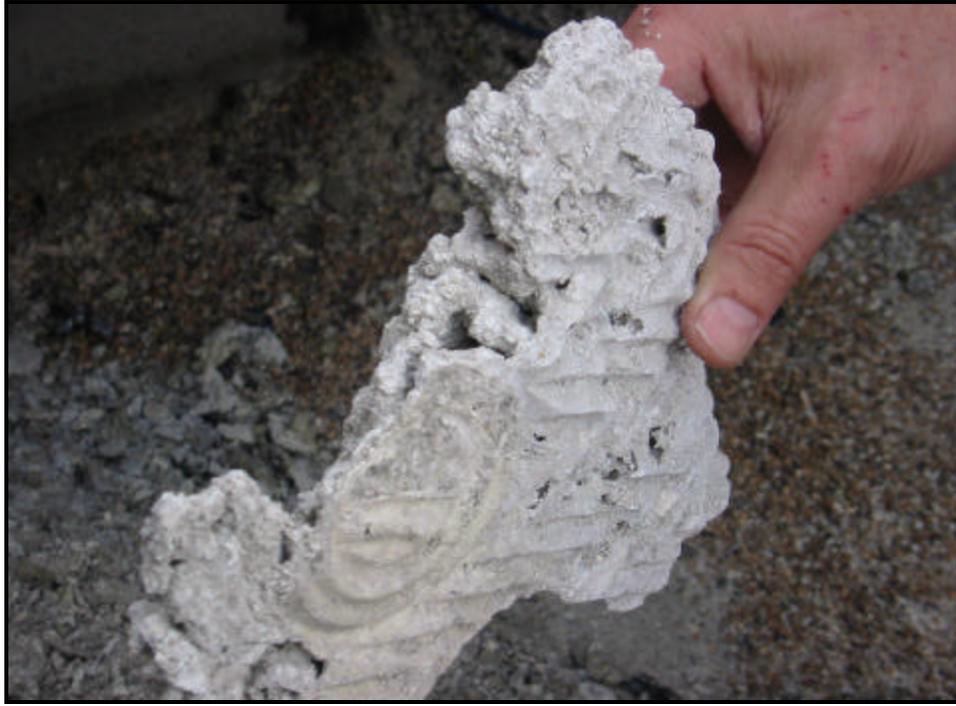
**Scale deposit showing media pattern 09/27/02 ...about 48 hrs**

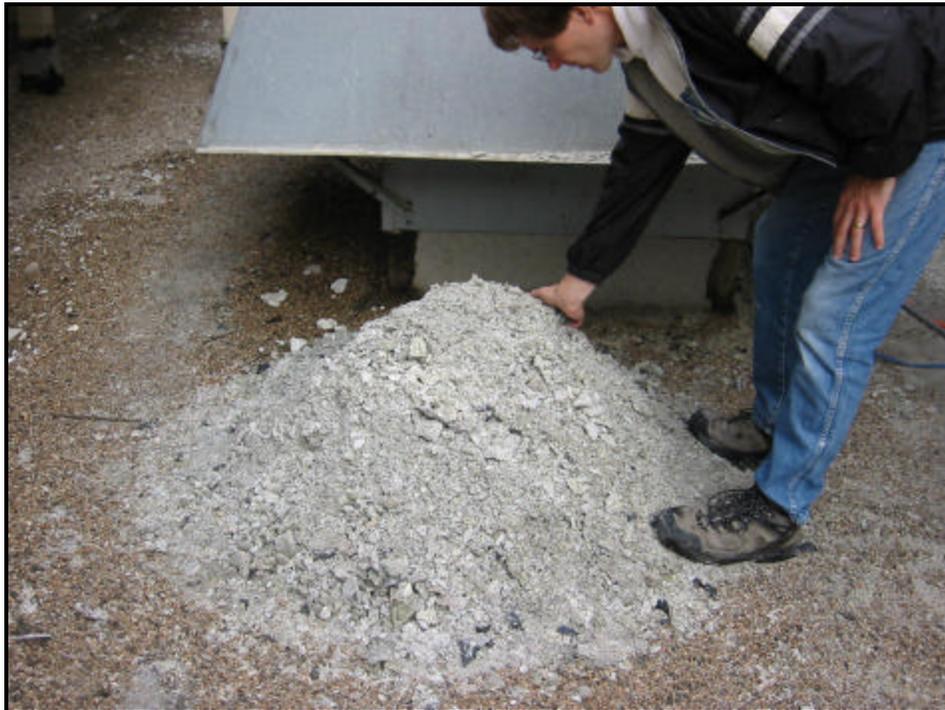
**Solid scale removed from tower.**

The pile of scale shoveled out of the tower measured 30" tall x 36" diameter. Total quantity of scale flushed down drain is unknown.
