OXCIDETM Greenhouse Treatment

Greenhouses build scale and organic deposits in water contact surfaces that compromise cooling efficiency, create hazards, reduce plant growth and create maintenance problems.

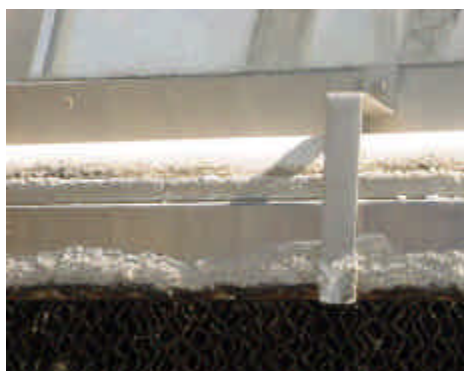
Initial scale on the water distribution pipe feeding the cooling pads and water contact surfaces on the window. Very low water flow resulted in inefficient cooling.

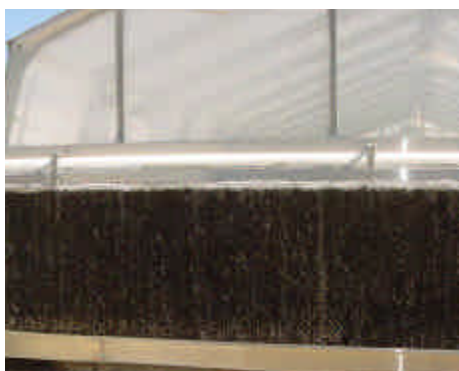
After 30 days treatment, scale was removed from the pipe and window surface. The cooling pipe emits strong stream of water.

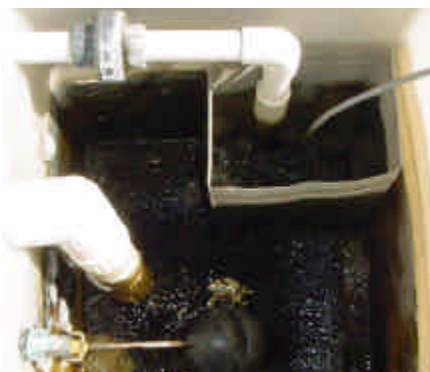
Initial heavy scale and organic loading on the bottom of cooling water circulation tank. Picture shown before Oxide™ treatment.

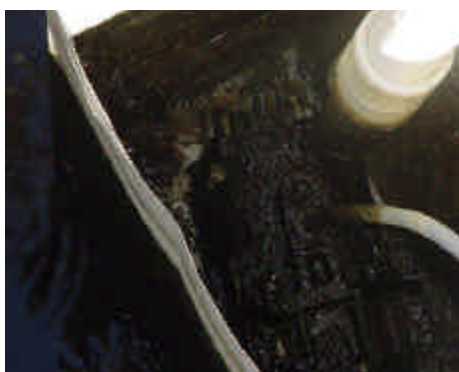
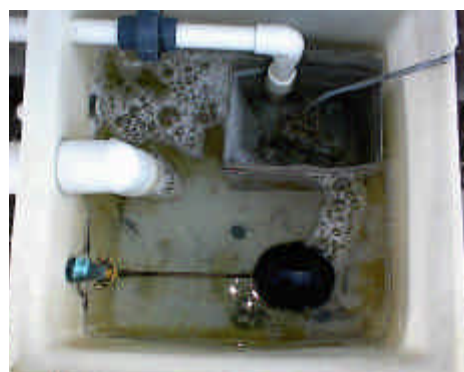
After 30 days treatment, scale and organic deposits were removed and no new scale was formed.
